Replacing the LEAD on a 1940 Packard 2-Door Sedan-

by Ron Carpenter

Part One:

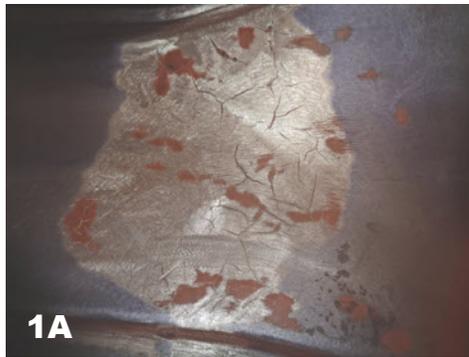
1A This is the Driver's side of the windshield and you can see the failure of the lead and that means that the metal under is exposed for corrosion....Rust.

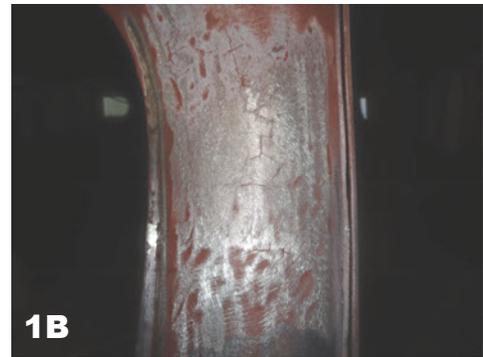
1B This is the passenger side of the car and it has the same problem and I need to remove the lead

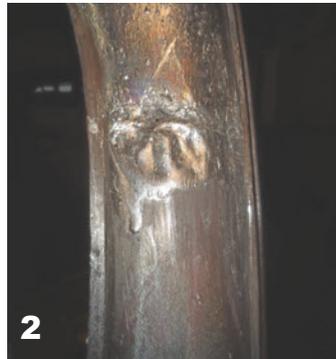
2. This is the post next to the door opening after I have removed the lead. They originally welded the metal together and then just beat it down and leaded it over.

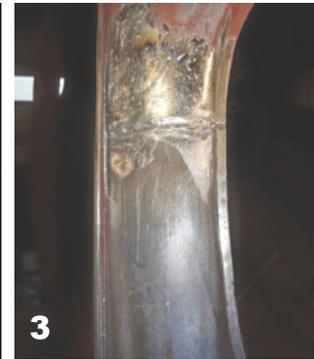
3. This is the Passenger side after I took the lead out....Now you know where the expression "get the lead out" comes from.

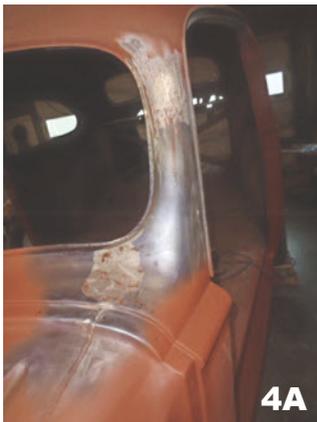
4A I still have the original lead at the window opening and I have played with the lead on the post.

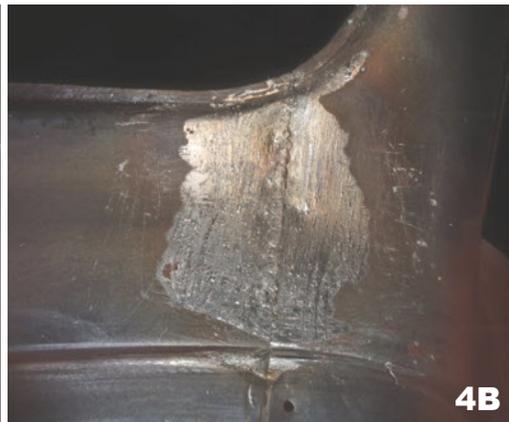
4B This is the driver's side from the windshield to the cowl after I have taken the lead out

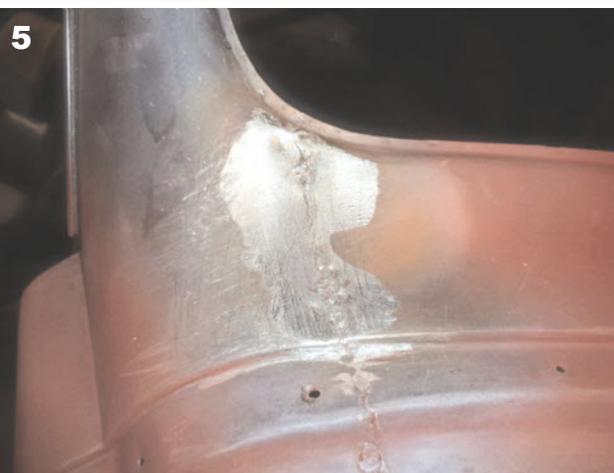
5. This is the passenger side from the windshield to cowl

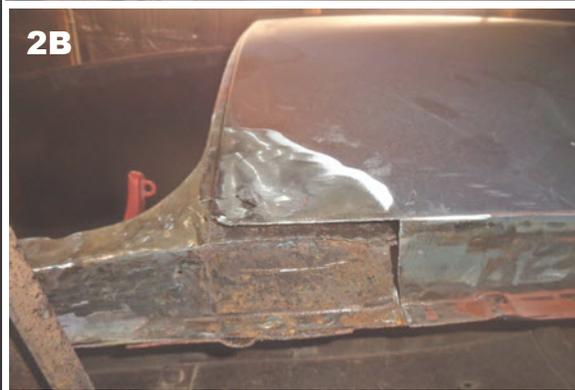
2A & 2B. these pictures show what the underbody area looked like when I removed the metal outside skin. You can see that it is rusted and I have cleaned it up.

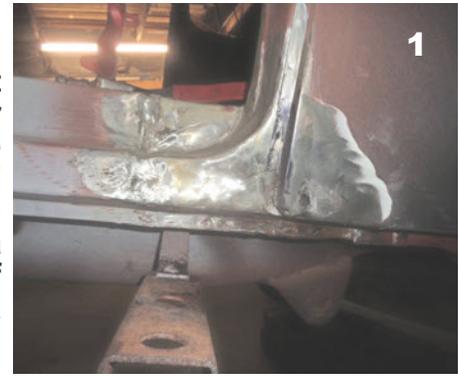
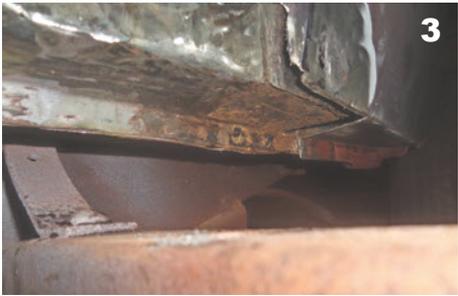
3. Another picture of the area and you can see that I have removed part of the metal that is originally welded to the door jamb in 1940 when Packard body men worked on it.

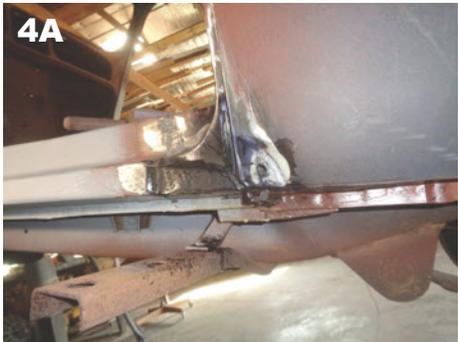
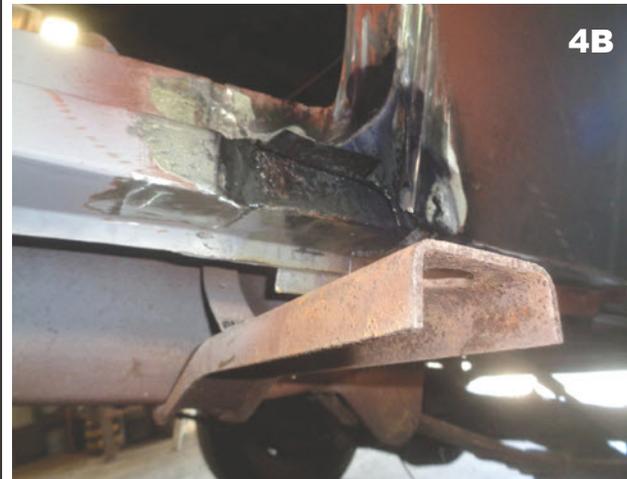
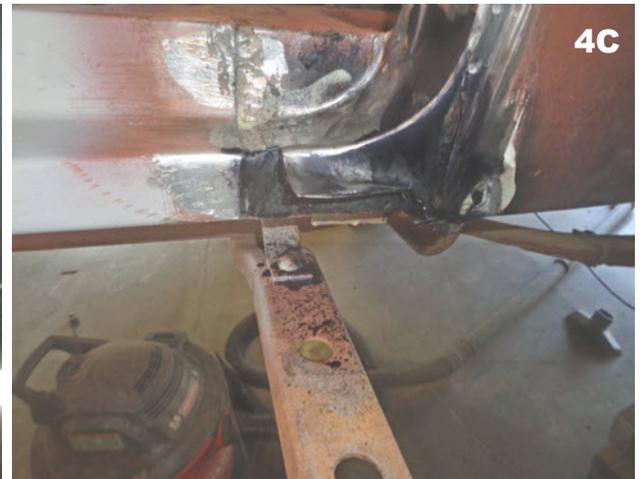
4B. Another picture of the area under the door jamb

4A. I have coated the area with the rust converter in preparation to repair the area.

4C. I have exposed more area and put the rust converter in the area. I should say that using the rust converter is also a problem to weld so I have to clean off some of the converter where I am welding.
