# SAVING THE BRAKE LINES ON A 1938 PACKARD CONVERTIBLE

*by Ron Carpenter*

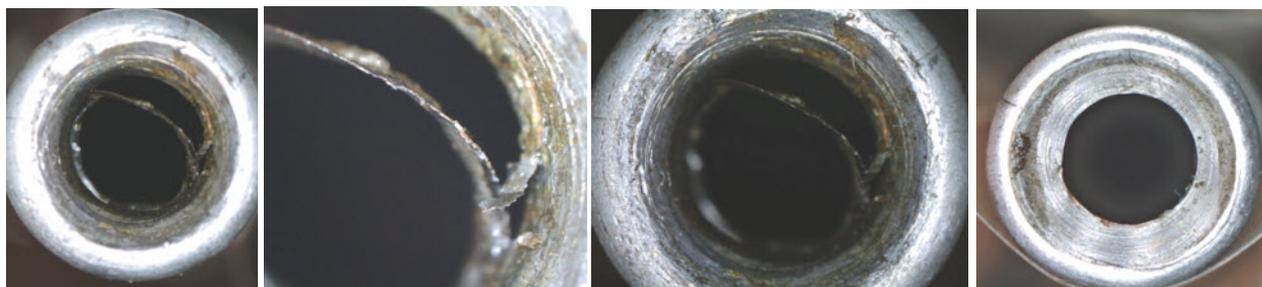
anywhere as everything was dry under the car and all the brake lines were dry as well. If it had regular brake fluid in it I would have found paint on the frame that was eaten off but with the silicone it does not eat any paint which is why people like it so well. Remember the car had basically not been driven very much so I guess that the silicone had just dried out and no trace of it was found. I removed the damaged brake lines and master cylinder and discovered that the lines had been tightened so tight that they damaged the tubing it self.

MAGNIFIED PICTURES SHOWING THE DAMAGED TUBING. FAR RIGHT: LIGHTLY HONED—WHAT A DIFFERENCE!

Once I had the lines made I used the KOUL tool to hone the brake lines. When you tighten up the lines after having honed the 45 degrees they tighten up so nice and just snug right up. I re-bled the system and then started trying to keep the master cylinder banjo fitting dry and it was a problem. I used new copper gaskets at the master cylinder and tightened the fitting slowly, wiping the brass

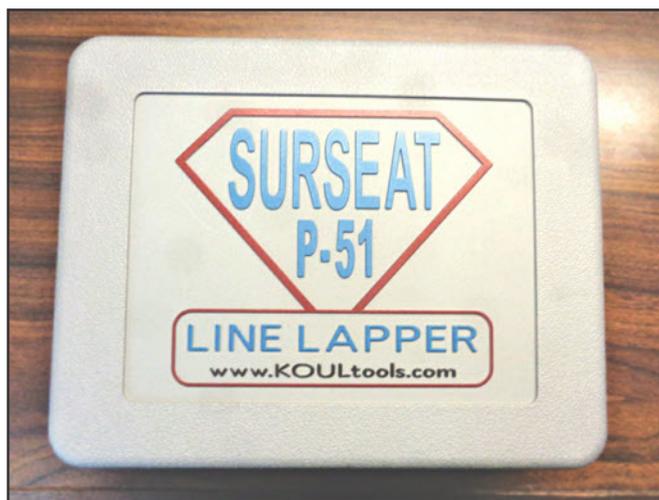
SURSEAT P-51 LINE LAPPER, Available online at [www.koultools.com](http://www.koultools.com)

I started with getting a new master cylinder from Max Merritt Auto Parts, as they had remanufactured the master cylinders when I originally repaired the system so the master cylinder was in good shape but I re-kitted the cylinder. I inspected the brake lines and I could see the damage so I remembered that my machinist John Rankin in Martinez had a microscope that is attached to his computer. The pictures that he took are shown under magnification and BOY do they ever give you an amazing picture of the problem. The pictures speak for themselves. There was cracking of the tubing at the inverted flare and it actually caused the metal to fail. In the process of dealing with the bad brake lines I made new ones, and I was talking my buddy Fred Hill and he had a neat tool for when you're making new brake lines. What this tool does is "hone" the 45 degree face of the brake lines after you made your inverted flair on the tubing. The tool company makes other angles for honing that have 37 degree angles also such as you might encounter on foreign cars.

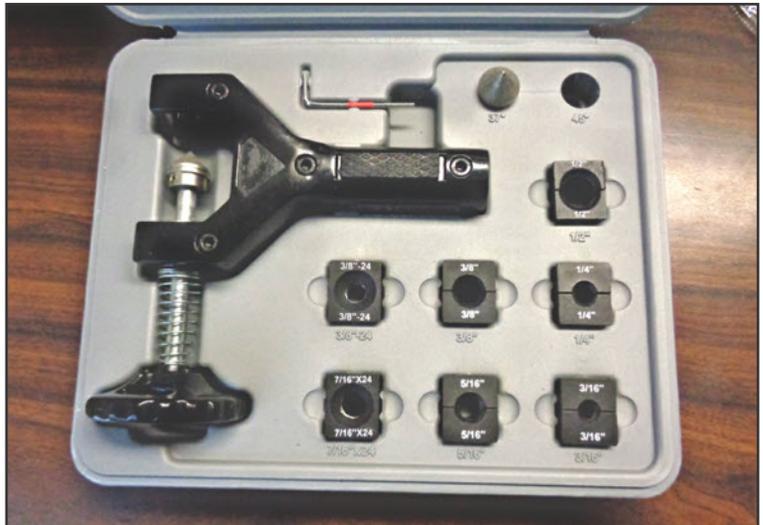
WHAT COMES IN THE BOX. BOTH 37 AND 45 DEGREE LINE LAPPERS INCLUDED.

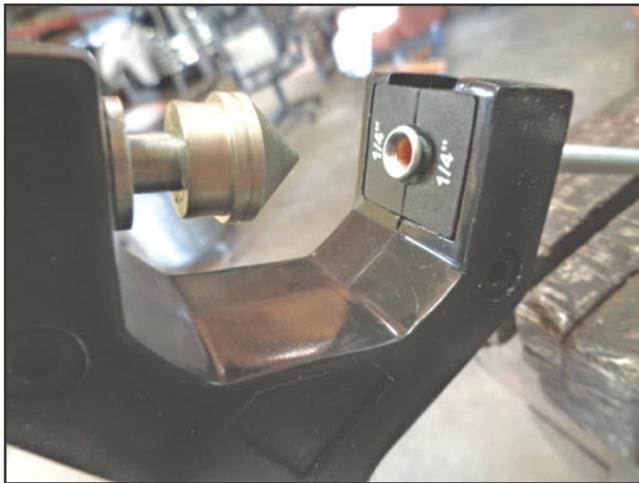
1/4" TUBING SET IN THE "JAWS" OF THE FIXTURE SETTING IT UP TO HONE THE 45 DEGREES

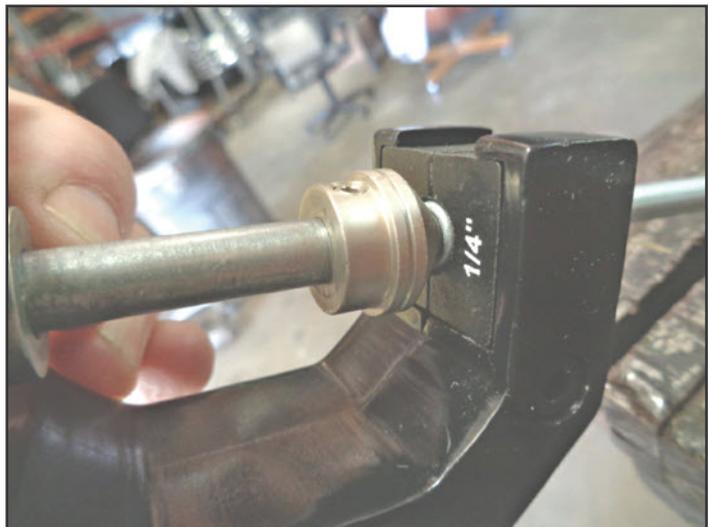
HAND-LAPPING THE 1/4" SEAT
