1940 PACKARD 2-Door Sedan— Continuing the Body Work *by Ron Carpenter*

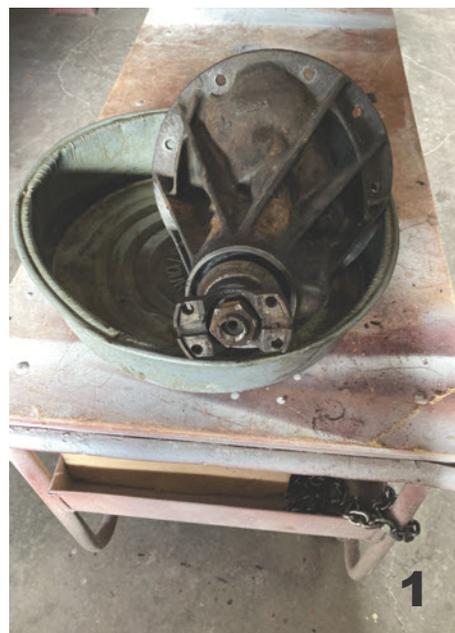
Picture 1

I have the nut loosened and ready to pull the flange. I normally mark the parts as I take them off with a punch mark and then tighten just a little more (1/8 of a flat on the nut) but since I am changing the flange I will just take it up smug and not too tight. I have seen the flange nuts come loose on other cars and just tightened them up with no problems, keep our fingers crossed that it will be fine other wise have to have the rear end reset with a new crush sleeve.

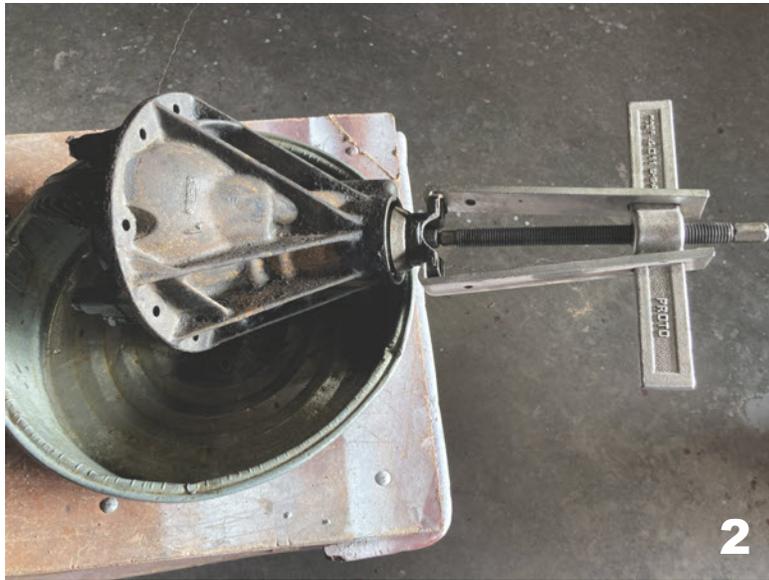
Picture 2

I am using a puller to remove the flange from the differential. Not too difficult to do but don't hammer on the flange, remember the universal joint goes on it and don't want to damage the area.

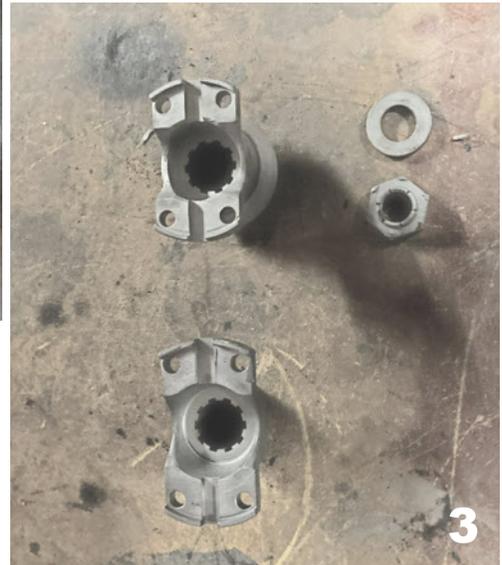
Picture 3

I have written in the beginning that I was going to change out the differential gears for a 410 ratio instead of the 435 standard non-overdrive ratio. On the 1940/1 6 cylinder cars they used smaller universal joints and as a result the flange is smaller but the parts are same size and I am going to use the 120 flange on the car as that is what my overdrive drive shaft is out of and it is the same length as the 6 cylinder overdrive cars. I have both the smaller flange and the larger flange laid out to show the difference.

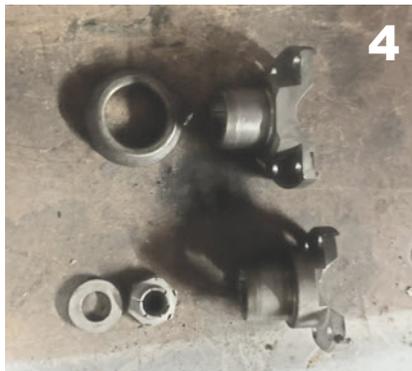
Picture 4

I have all the parts laid out again to show the actual unit before I polish and I have removed the slinger ring from the universal joint. This was just pressed on. I have all the parts laid out before I install the slinger ring. I will be using thread lock to reinstall the slinger ring back on the flange.

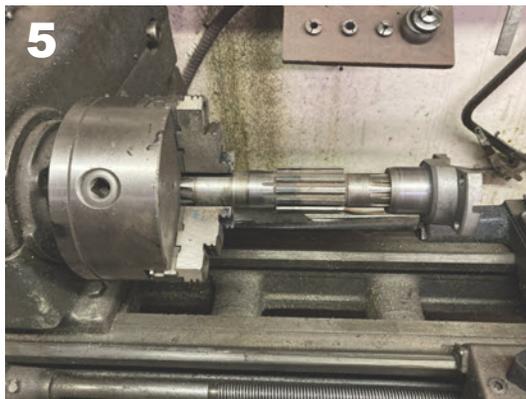
Picture 5

I am using a transmission main shaft that has had all the gears taken off and I put the flange in the lathe and polish the seal area with 400 grit wet and dry paper. I have bead blasted the parts in preparation to do this.

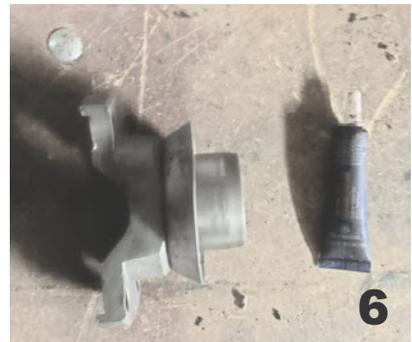
Picture 6

I am going to use a thread lock to install the slinger. When I pulled the slinger ring off I felt that it might get loose so I Loc-tited the slinger back on. It is

probably overkill as I believe that the ring will be held tight once it is installed.

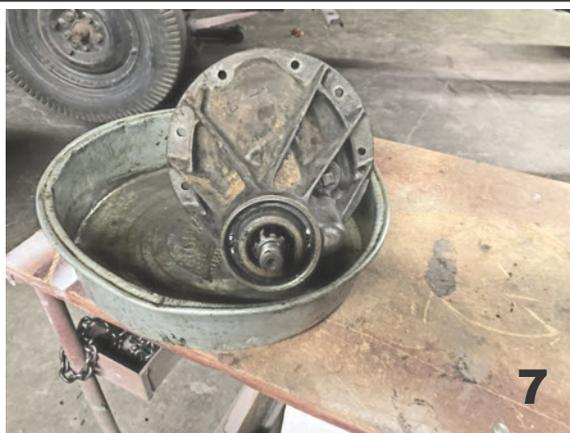
Picture 7

I am now going to remove the rear seal from the "pumpkin" as I like to call it. I have started by drilling two 1/8 holes in the retainer which I will use to remove the seal. Packard put a seal in the retainer and I will remove the retainer and press the seal out of the retainer. The actual seal is the same dimensions as used in the junior and senior cars so one fits all but different retainers to hold the seal.

What it looks like before I pull the seal

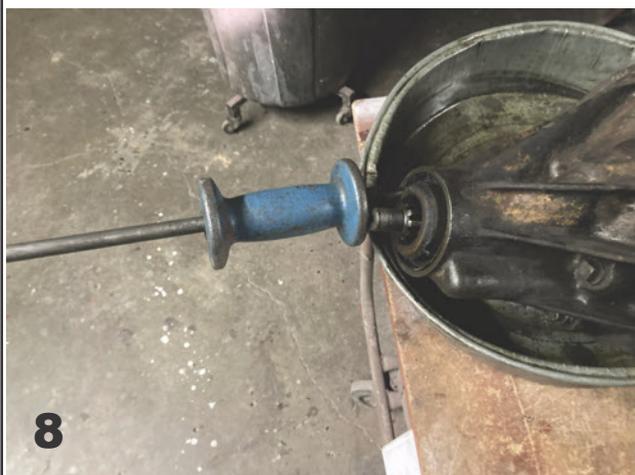
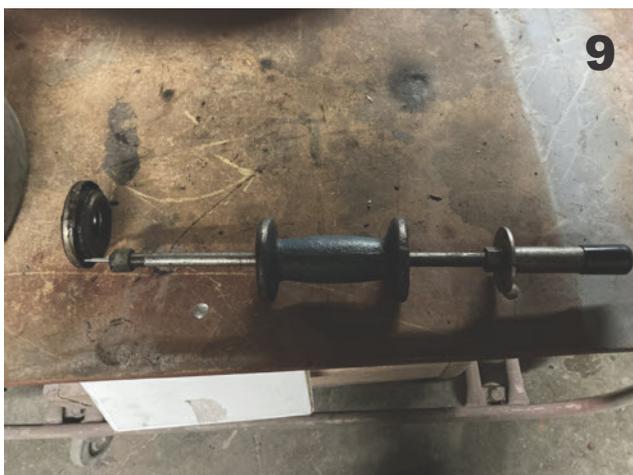
Picture 8 and Picture 9

I have my slide hammer screwed into the seal retainer and ready to pull out seal and the seal is now out of the pumpkin. When you do this only pull it out slowly as you can easily pull the screws out of the retainer.

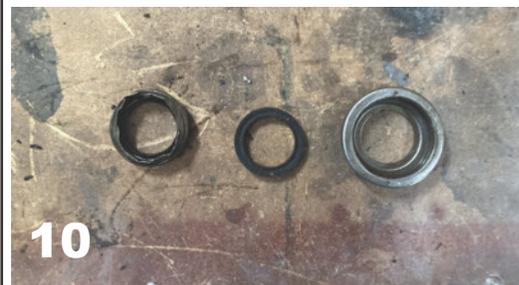
Picture 10

I have the seal retainer with the wiper seal and the old seal. I am ready to clean the retainer to reassemble the seal.

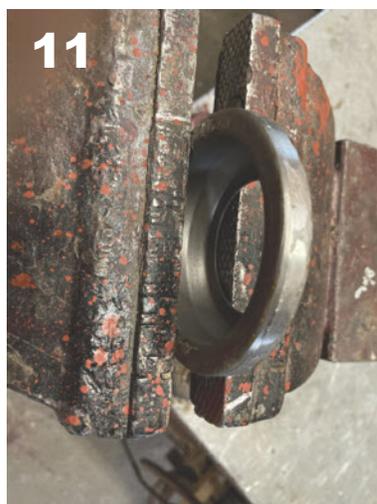
Picture 11

I have set up and soldered the holes in the seal that I drilled and I will be soldering the metal around the seal retainer so that when I install the seal it will help make a seal area that will not leak.

I want to expand on why I soldered the outside of the retainer. I had one '47 clipper that I put three rear seals in before I realized that the retainer it self was leaking and not the seal. I was using a new reproduction seal and I am not sure why it was leaking because it was not the right size or if there was a "scar" in the area that caused it to leak but the solution I came up with was to solder around the retainer

and when the retainer was installed it cut off any excess solder that was displaced when I installed the seal. The new seal did not leak so I have done it this way every since. This was years ago and I am sure if it was the problem with the reproduction seals that they (vendors) would have fixed the problem by now.

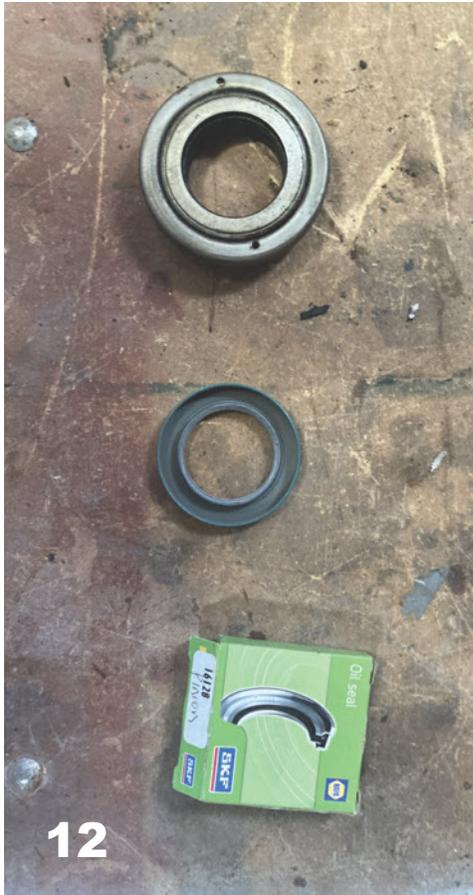
Picture 12

I have laid out the parts before I start to assemble the seal. I machined a metal adapter to press the seal into the retainer so that I could put it in straight. I have bead-blasted the retainer before I solder up the holes.

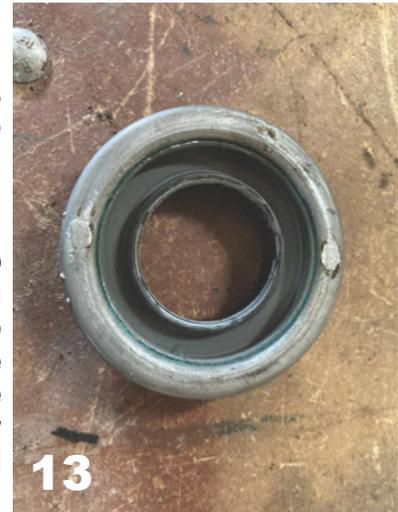
Picture 13

I have installed the new seal and the wiper seal and it is ready to to install in the pumpkin.

Once I have the seal ready to reinstall I used the retaining nut with a large washer to slowly push the seal in to the housing. I only used a little force at a time and gently tapped the seal into place until it was flush.

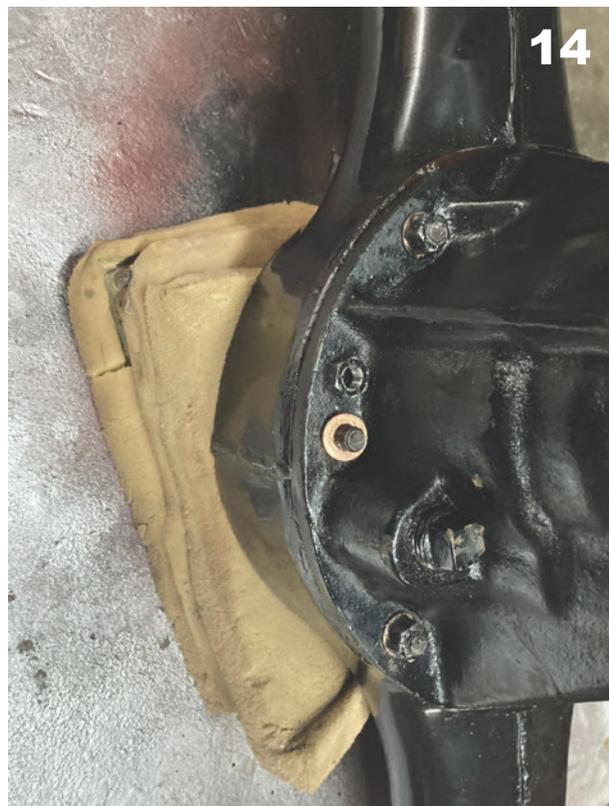
Picture 14

Once the seal is back in the case the pumpkin is ready to install in the rear differential housing. Use a new gasket (obvious I know but don't use just silicone as a gasket material as I have seen cases where it "washes" out) but on the lower half of the housing use copper washers to seal the threads of the bolts. Packard used copper washers and self locking nuts. Don't put a lock washer against the copper washer.
