Before starting repairs on our '46, we located our motors manuals and newsletters and set up our team, then we were ready to start. After **SOLENOID** studying the manual and before testing, we made sure it was getting current through the system, starting at the source-the 30-amp fuse at the starter (It's hot all of the time). Since the unit had been inoperable for years, every contact was cleaned. The fuse was removed and tested and the wire contact ends to it cleaned. Each wire was checked for oxidation and CONTINUED

R-9 SCHEMATIC

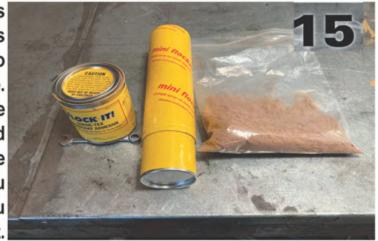
number 15

This is what the flocking kit comes with. The only reason the wrench is under the adhesive can is just to hold the can up a little for the picture. The kit comes with adhesive in the color of the flock. You get a pound of flock with the kit and unless you're doing the trunk it is plenty and if you are going to do a trunk then you should get a flocking gun to do that.

The yellow tubes are what blows the flock on to the parts. Just a quick little air pump and you really don't need to get the flocking gun out just to do that little glove box door. You could even pour the flock on the wet glue if you wanted to but this is more consistent.

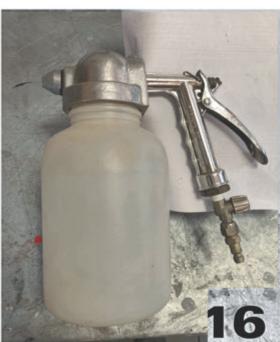
Number 16

This is what a flocking gun looks like. My Buddy Armand loaned the gun to me and when I do the trunk this is what I will be using to do that.

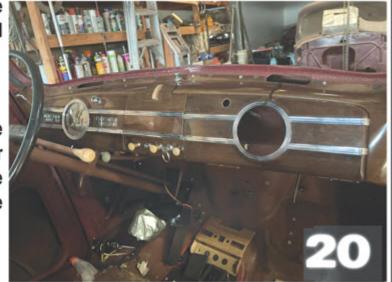
This is what the dash looks like now that all the chrome and door are in place. I have to install the lock and the clock but that will be later.

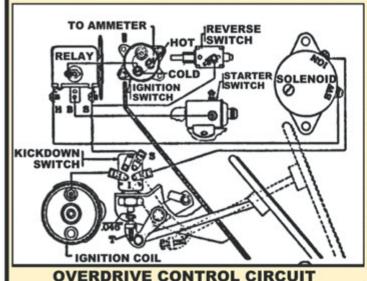
With current going to all components in the circuit, it was time to test the solenoid and governor. We called on our Packard buddy Ron Carpenter to help go beyond the manual for the solenoid testing. The goal is to get the plunger to kick in and out, which activates the overdrive.

TO TEST: With the solenoid off the car, take a 6-volt battery and connect a pigtail to the battery's positive terminal, and then to the case of the solenoid (rubber gloves are recommended). Then take a pigtail from the negative battery terminal to #3 terminal on the solenoid (the numbers are stamped on the solenoid). The plunger will start popping in and out. Then take a pigtail from the negative battery terminal to #4 terminal on the solenoid. This will stop the plunger in the

out position. Our solenoid didn't work (the plunger wouldn't move). We called our buddy David Moe, owner of Packard Seattle Company (425-334-7754), to rebuild it. He had a rebuilt one on the shelf and we had it in a week. When it was hooked up and tested, this time it worked.

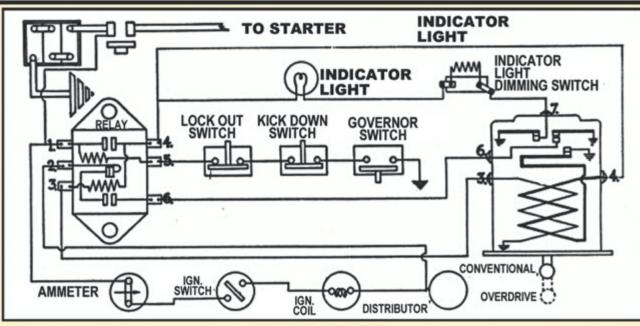
continuity.* This is a positive ground system, so we followed the ground circuit through the switches to the governor then tested for continuity to the solenoid (see wiring diagram for components).
