# DRIVING OLD CARS

## Borg-Warner's R-9 OVERDRIVE: Troubleshooting

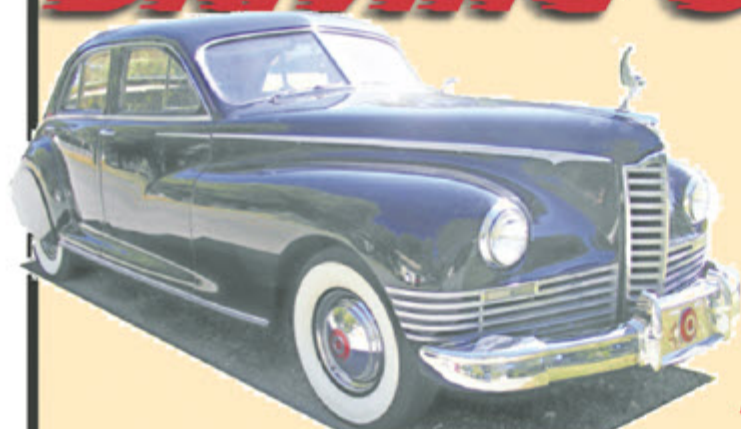
**A**s we continue to bring our long-sitting 1946 Packard 356 up to standards, we discovered another problem. This time it is the R-9 overdrive. It doesn't work. Although when we stopped driving the car, it had been gone through. It has stopped working. Here in Georgia, it is very humid and I am thinking some of the connections have oxidized. Using Packard's R-9 System Review, we will go through each step.

Before starting repairs on our '46, we located our motors manuals and newsletters and set up our team, then we were ready to start. After studying the manual and before testing, make sure you are getting current through the system. Start at the source—the 30-amp fuse at the starter (It's hot all of the time). Since our unit had been inoperable for years, every contact was cleaned. The fuse was removed and tested and the wire contact ends to it

**TO TEST:** With the solenoid off the car, take a 6-volt battery and connect a pigtail to the battery's positive terminal, and then to the case of the solenoid (rubber gloves are recommended). Then take a pigtail from the negative battery terminal to #3 terminal on the solenoid (the numbers are stamped on the solenoid). The plunger will start popping in and out. Then take a pigtail from the negative battery terminal to #4 terminal on the solenoid. This will stop the plunger in the out position. Our solenoid didn't work (the plunger wouldn't move). A friend of ours had a rebuilt one on the shelf and we had it in a week. When it was hooked up and tested, this time it worked.

While we had been waiting for the solenoid, we tested the governor. We removed the cover, cleaned the contacts, then hooked it up to a drill to make sure the sling weights came out. As they spin, they cause a micro switch to close and complete the circuit. The purpose of the governor is to provide a ground for the system. Ours worked fine.
